# NUKE INFO TOKYO

Nov./Dec. 2013

No. 157

## No future for Kashiwazaki-Kariwa except gradual decommissioning

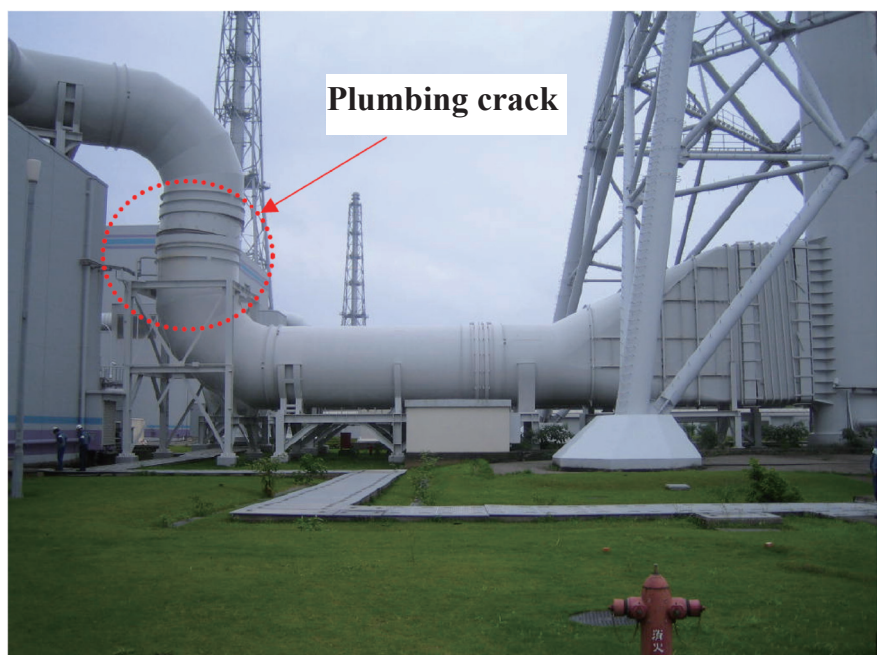
KKNPS was hit hard by the Chuetsu-oki earthquake and suffered serious damage in more than 3,000 locations. Concerned about this, in August 2007 a number of scientists and engineers established a group calling for the closure of the nuclear power plant. Other experts from all parts of Japan are participating in this group, which continues to hold scientific and technological discussions on the plant from a critical point of view. The group is presenting its opinions to the Niigata Prefectural government, local residents, as well as to the national government. Even if TEPCO is eager to restart reactors at KKNPS, there is little chance of realization of this plan.

*Plumbing crack at KKNPS that occurred during the Niigata Chuetsu-oki Earthquake in July 2007. Photo by TEPCO*

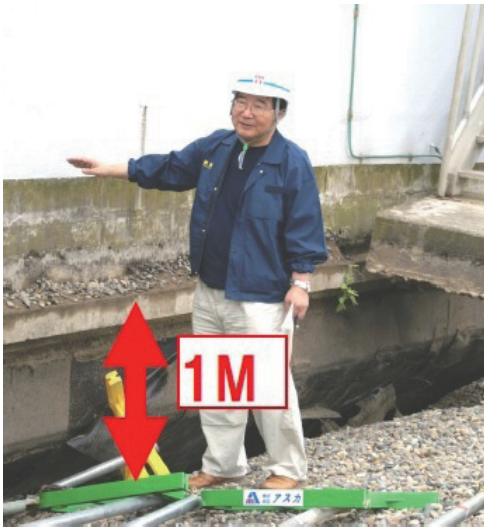
*One-meter ground subsidence at KKNPS that occurred during the Niigata Chuetsu-oki Earthquake. (Reported in the 20 questions and answers on why KKNPS must not restart.)*

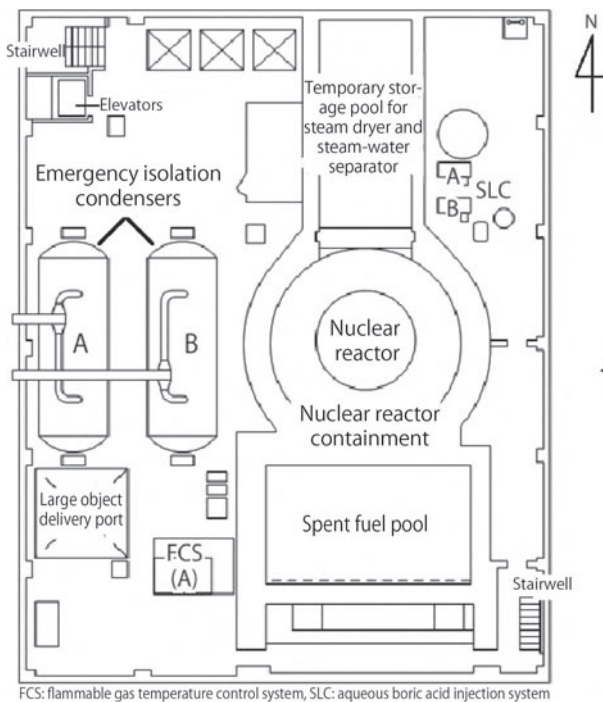
**Fig. 1** Fourth floor plan of Fukushima Daiichi NPP Unit 1 reactor building (prepared by the Citizens' Nuclear Information Center, based on figures appearing on TEPCO's website).

The first is that “water leakage phenomena,” with water suddenly gushing out from somewhere, did occur right after the earthquake on the 4<sup>th</sup> floor of the Unit 1 building, where the IC units were located. This leakage was witnessed by several employees who happened to be working on the 4<sup>th</sup> floor at that time.

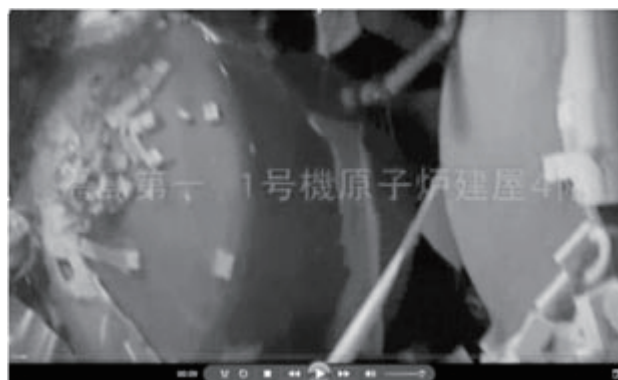
For example, the explanation in the excerpt above says, "*The insulation on the south side of the IC was severely torn ...*" Indeed, Photo 1 shows the metal cover and insulation on the IC units (cylindrical tanks) had been violently stripped off. TEPCO adds the explanation that this occurred because of the blast from the hydrogen explosion on the 5<sup>th</sup> floor passing through the opening (equipment hatch). Such a case, however, would have been impossible, as explained below.

Photo 1: The two IC units (4<sup>th</sup> fl., Unit 1 bldg.)

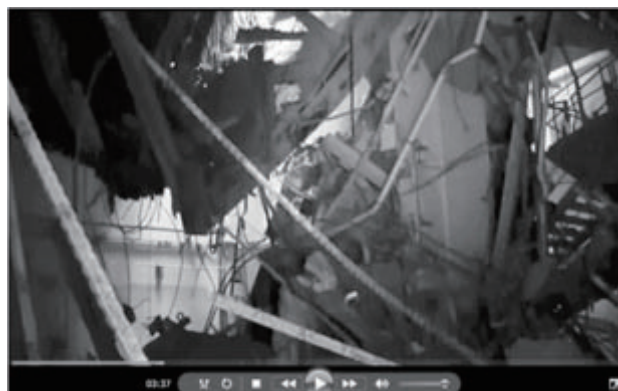
TEPCO investigated the 4<sup>th</sup> floor of the Unit 1 building several times, and each time they recorded scenes of violent destruction of the 4<sup>th</sup> floor interior in their survey videos (Photos 1 and 2). TEPCO gave the following explanation on what could have caused such violent destruction in its final report published in May of last year.<sup>(7)</sup>

Photo 2: Immense destruction on the 4<sup>th</sup> floor of the Unit 1 building.

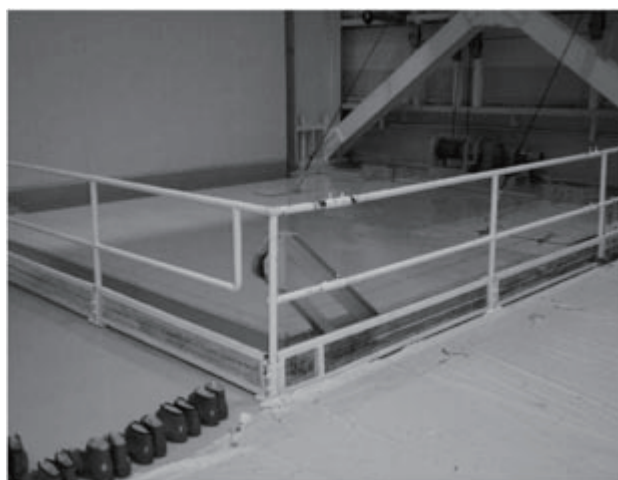
The opening described in the explanation is a square-shaped hatch with sides of about 5 meters each on the floor of the 5<sup>th</sup> storey (i.e., the 4<sup>th</sup> storey ceiling). This hatch is used when delivering large pieces of equipment or materials, so it is often simply called an "equipment hatch," but when it is not in use, it is covered with a steel lid (weighing about 1.5 tons), as shown in Photo 3, to prevent falls. Also, during the NAIIC investigation, we confirmed that the equipment hatch had been in use shortly prior to the earthquake, but had been closed, according to veteran workers, after the delivery operations had finished, just a little before the earthquake.

Photo 3: The steel lid of the equipment hatch on the 5<sup>th</sup> floor of the Unit 1 building.

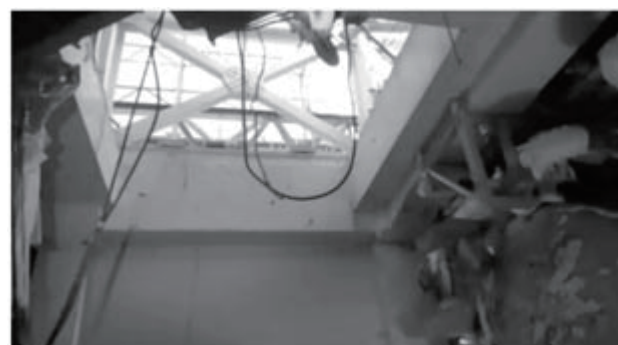
Photo 4: Looking up from the 4<sup>th</sup> floor to the equipment hatch (the steel lid blown away by the hydrogen explosion is missing, an IC unit is visible to the right).

In other words, at about 2:30 p.m. on March 11, 2011, the equipment hatch was closed. From then on until after 3:30 p.m. on March 12, when the hydrogen explosion occurred, the hatch should have remained shut, so inasmuch as the steel hatch was not blasted downward into the 4th floor from an explosion on the 5th floor, there should not have been any blast coming through the equipment hatch and tearing insulation off the IC units on the 4th floor, and judging from the lack of any hatch being discovered on the 4th floor, it can be said that nothing of the sort happened.
